HISTORIC RESOURCES INVENTORY FORM

For Buildings and Structures

1. BUILDING NAME: Common: Town Farms Inn Historic: Thomas G. Mather House; Town Farm
2. TOWN/CITY: Middletown VILLAGE: _____ COUNTY: Middlesex
3. STREET & NUMBER (and/or location): Silver Street; north side, corner of River Road
4. OWNER(S): Town Farms Inn, Inc. PUBLIC PRIVATE
5. USE: Present: Resturant Historic: Almshouse; residence
6. ACCESSIBILITY TO PUBLIC: Exterior visible from public road: yes no
Interior accessible: yes, explain Dining quarters no

Town Farms
Silver Street, Middletown, Ct. 06457

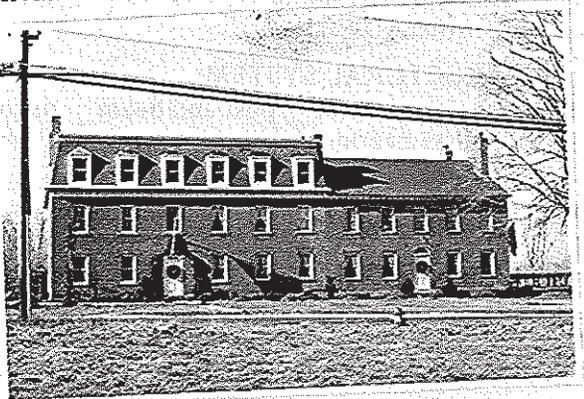
photographer: Robert Svec
date: 12/78 view: south
negative on file: Roll 53, #27-27A

18. HISTORICAL OR ARCHITECTURAL IMPORTANCE: This structure has two, large sections of different styles. The earliest part was built as a residence for Thomas G. Mather between 1835 and 1839, a later date than its Federal style implies. The five-bay facade has a central entrance. Two pairs of chimneys are on either end of the gabled roof and mutules are exhibited beneath the cornice. In 1853, Mather sold the building to the town of Middletown, which used the premises to house the city's poor, terminating the use of the city's first Almshouse (53 Warwick Street). Its occupants also worked the farm which adjoined the structure. During the city's ownership, a plainly styled, two-story rear wing was added to the rear of the original section around 1870. The large three-story addition was erected to the side in 1890 or '91. This latter section has a mansard roof reminiscent of the Second Empire style. It displays plainly decorated dormers and slender brackets beneath the eaves. The City of Middletown sold the property in 1946. The building was later converted to a restaurant and has since been utilized for this purpose. This distinctive structure is an interesting unification of two divergent styles. The mansard roofed addition is more simplistically decorated and was built at a much later date (see continuation sheet)

than most of its contemporaries. Like the earlier Federal section, it has smooth brownstone sills and lintels, and a fanlight above the entrance. These features combined with its sparse detail, make the addition compatible with the original Federal section.
